CONDITION SURVEY OF DEPERE LOCK AND DAM LOWER FOX RIVER, WISCONSIN

Richard L. Stowe, Joyce C. Ahlvin

June 1982

Final Report

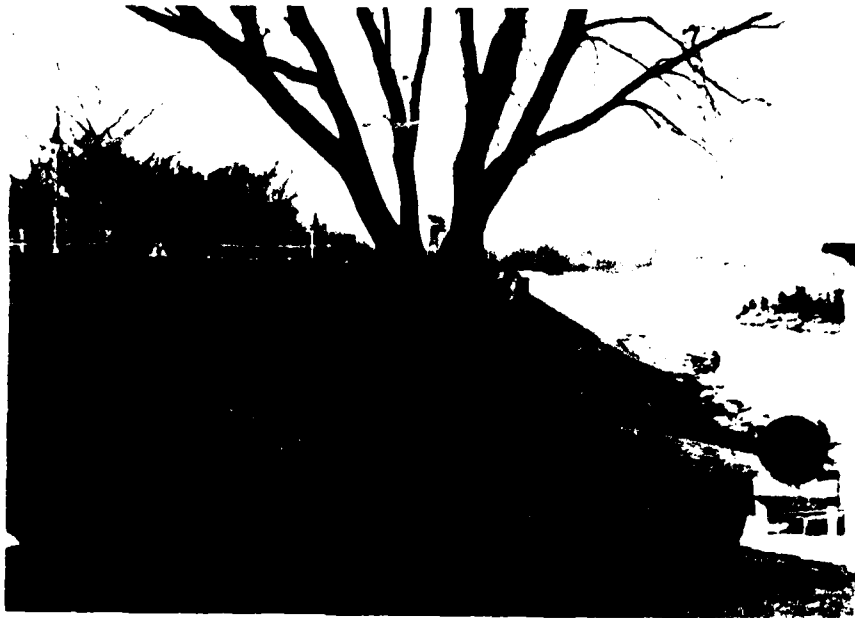
13. The grassed embankment adjacent to both lock walls appears in good condition with local areas showing a little differential settlement in the order of 5 to 9 in. The side slopes are about 1 vertical to 2 horizontal. There is no evidence of seepage. (See Photos 8 and 9 (Appendix A).)

Photo 8. Taken from near upper gates on right side of lock embankment, looking downstream, minor settlement evident but embankment in good condition.

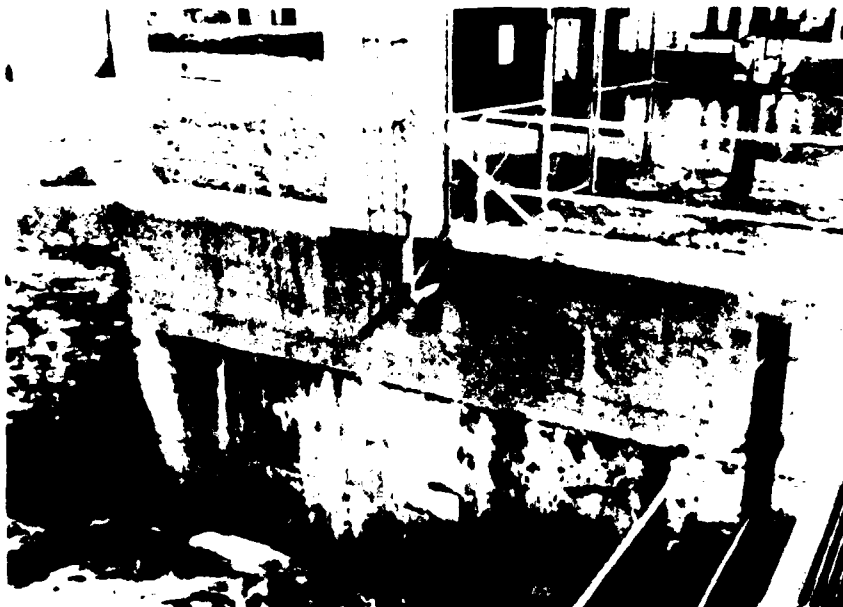
Photo 11. Taken from right spillway, looking at downstream portion of right dam abutment pier. Top concrete in good condition. White exudation coming from horizontal joint and cracks.

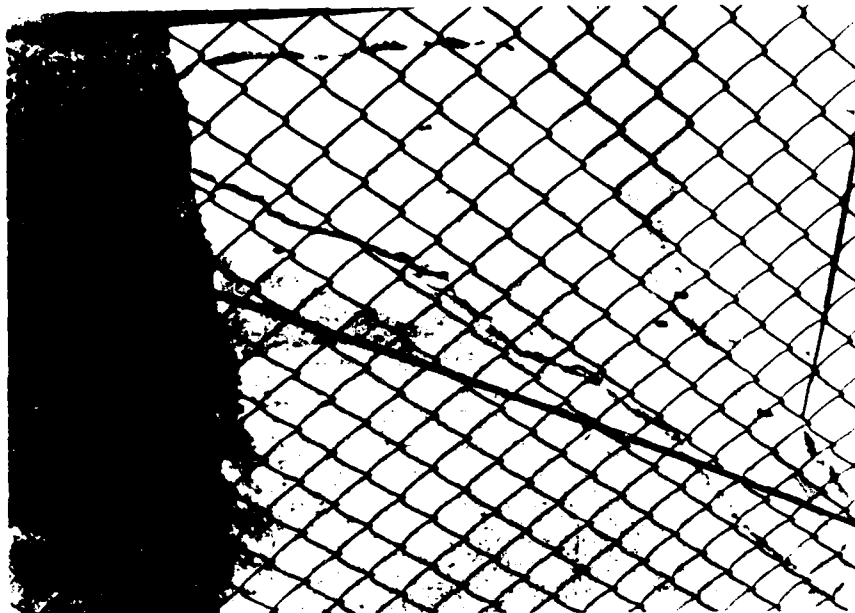
crack (>2 mm, 0.08 in.) can be seen on the top and dam side of the pier. Photo 12 (Appendix A) shows relative movement along the crack. There is no concern about the stability of the pier due to this crack. However, the crack should be measured periodically; if large movement occurs, remedial measures can be taken.

Photo 12. Taken from right abutment, looking upstream at wide crack on top of abutment pier. Cracked section of concrete appears raised.

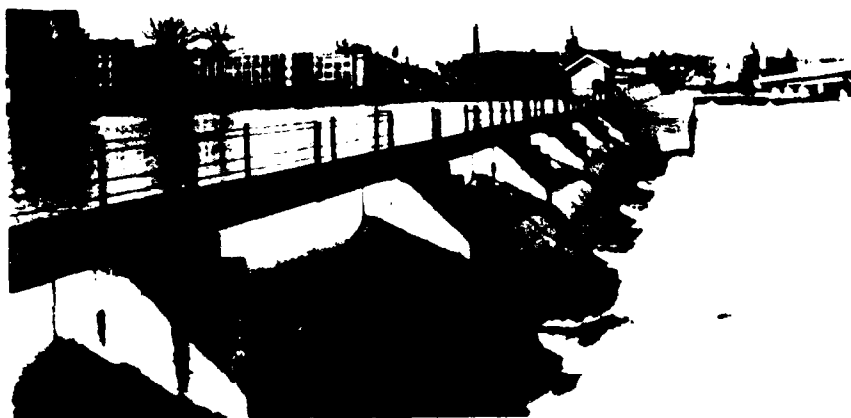
Photo 13. Taken from right dam abutment, looking across right spillway. Minor amount of white exudation and cracking; spillway pier No. 1.

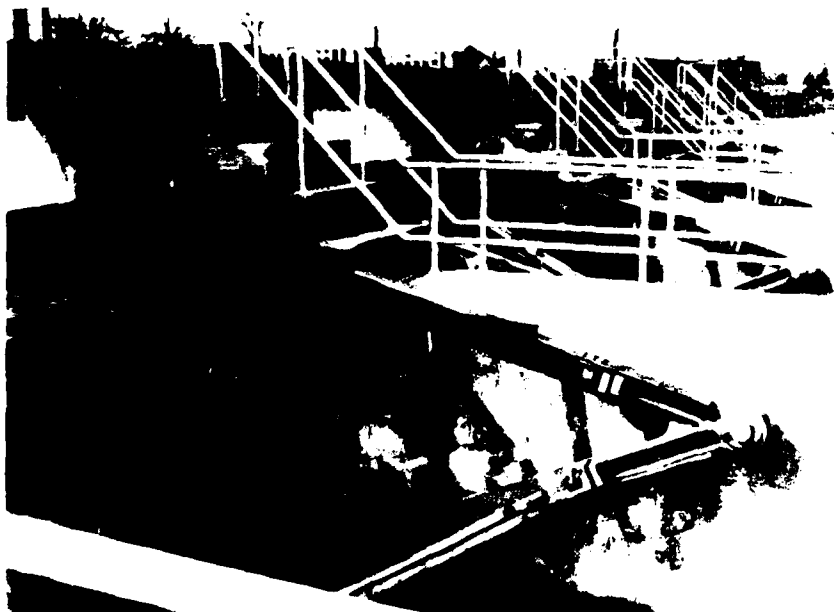
17. The condition of the concrete in the sluiceway piers is generally good (see Photos 15 through 18, Appendix A). Damage due to freezing and thawing is confined to local areas; the presence of cracks and exudation is evidence of the damage. Small areas of concrete in the piers at and near low pool elevation have been eroded by water and ice action. A few piers have cracks through the piers near the gate hinge pins. Cracks are similarly located in the piers of Cedars Dam on the Lower Fox River. The Chicago District conducted a stability analysis of the cracked concrete piers at Cedars Dam and determined that reinforcement within the piers was effective for gate loads; see Reference 1, Appendix B, page B-4. The analysis made for the piers at Cedars is applicable for the piers at DePere; they have the same dimensions and reinforcement.

Photo 15. Taken from sluiceway pier No. 10, looking upstream. Except for local cracking and exudation, concrete is in generally good condition.

18. It is suggested that a study be made to determine if the reinforcing steel in the sluiceway piers is rusted. Infiltrating water along the cracks could have caused reinforcement to rust. The concrete from around the downstream side of the gate hinge pin could be excavated to examine the reinforcing steel. The damaged concrete in the sluiceway piers appears to pose no problems at this time. Repair of damaged concrete could be handled during routine maintenance.

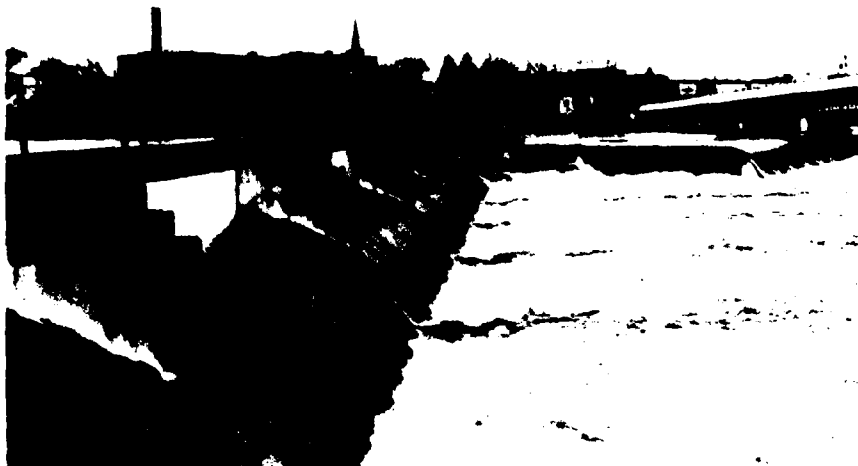
19. The concrete in the foot bridge piers is in generally good condition. Local cracking and exudation is present. See Photos 19 through 21, Appendix A. Light erosion is present near the waterline of the piers; see Photo 22, Appendix A. Concrete repair on the noses of several piers is in good condition. Repair of the damaged concrete could be done during routine maintenance.

Photo 19. Taken from sluiceway pier No. 15, looking across left spillway, concrete in pier in good condition. Private dam seen just downstream of left abutment.

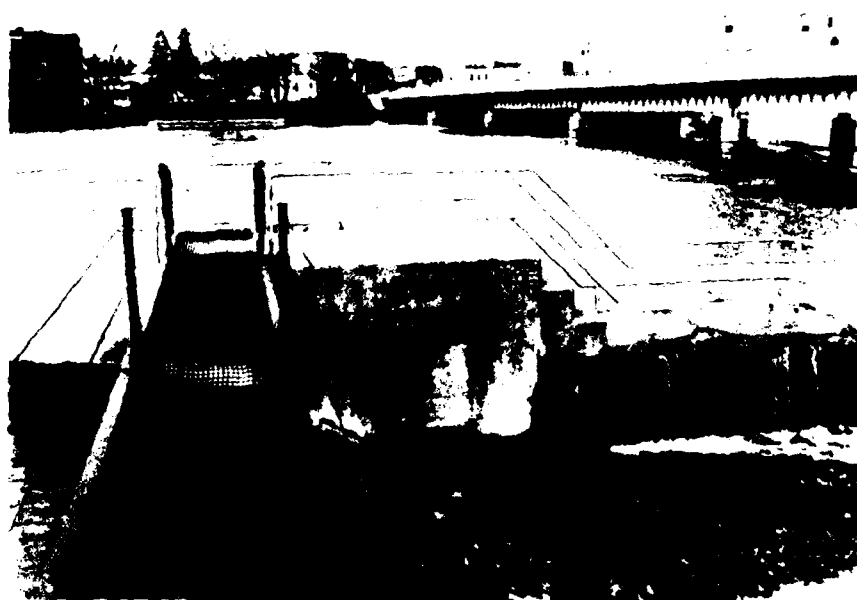
Photo 23. Taken from left spillway, looking at left dam abutment pier.

20. The concrete in the middle and the upstream portions of the left abutment pier is in good condition; a few cracks, some exudation, and light erosion is present. The uppermost downstream portion of the pier (see Photo 23, Appendix A) is heavily deteriorated. This portion of the pier is partly submerged and has sustained more freezing and thawing damage than the remaining concrete in the pier because it is critically saturated. Erosion (by water and ice) has also caused some of the damage. Reinforcing steel is exposed at the downstream face of the pier but only at the waterline.

21. It would be wise to check the integrity of the internal concrete in this section of the pier. If the internal concrete is sound, then repair to the external concrete can be made during routine maintenance. Nondestructive tests, such as ultrasonic velocity measurements, could be made to check the soundness of the internal concrete; core borings could likewise be used.

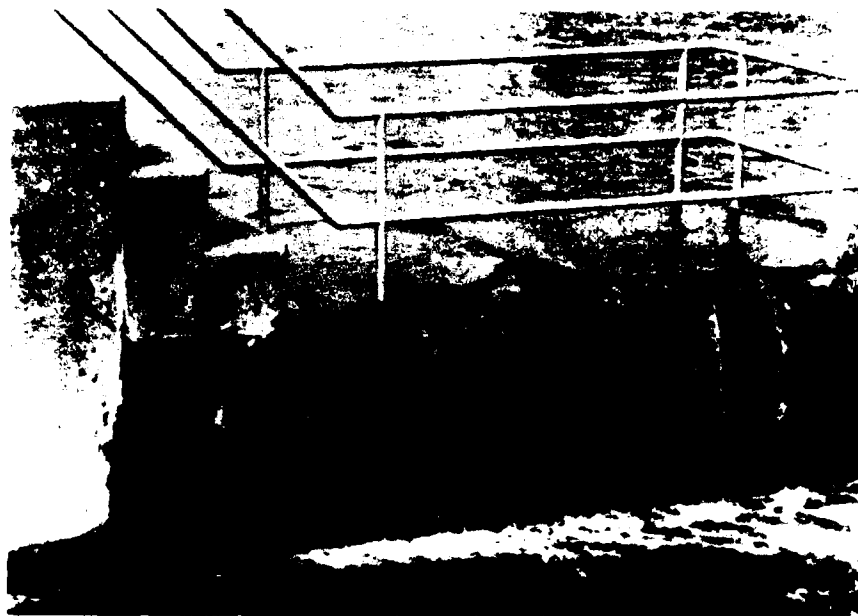
Photo 24. Close-up of downstream end of left abutment pier.
